Manhole Inspection Summary

Manhole # S06CC2009MH

Record Plat: **06CC2** Node: **009** Status: **Confirmed Exists - Buried** Insp Date: **7/12/06 8:29 AM**

Location Address: **6902 PARK HEIGHTS AVE** Cross Street: **FALLSTAFF RD**

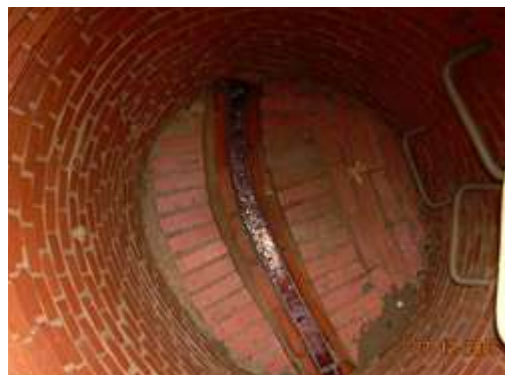
Top View

Corbel and Barrel infiltration. Bench debris.

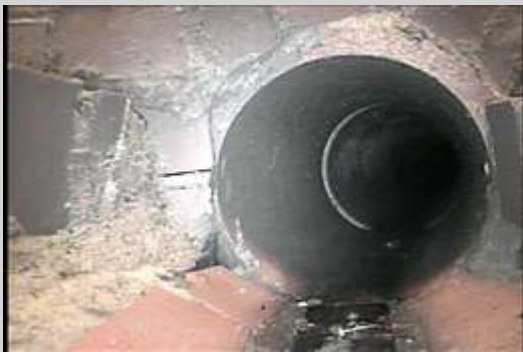
8 in. Circular Gravity Sewer Pipe Out @ 12 O'Clock

Comments **The O12 pipe picture shows Channel deterioration.**

Channel Material: **Brick** ☐ Parged ☐ Debris (not Condition related)
Channel Exposure: **Fully Open** Junc Dist: **0.5** nearest .5 ft. Azimuth: **5**
Condition: ☐ Sound ☐ Cracked ☐ Root Intrusion ☒ Deteriorated ☐ Leaks ☐ Debris

Infiltration: **Evidence** Pipe Seal Cond: **Unknown**

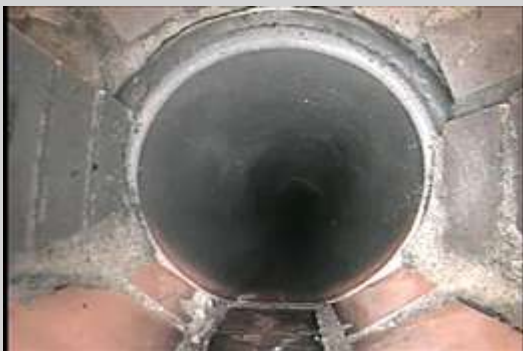
8 in. Circular Gravity Sewer Pipe In @ 5 O'Clock

Infiltration: **Evidence** Pipe Seal Cond: **Unknown**
